This Service Information bulletin supersedes SI M11 02 07 dated **September 2010**.

Rattle Noise from Engine

R55 Cooper S with N14 engine

R56 Cooper S with N14 engine

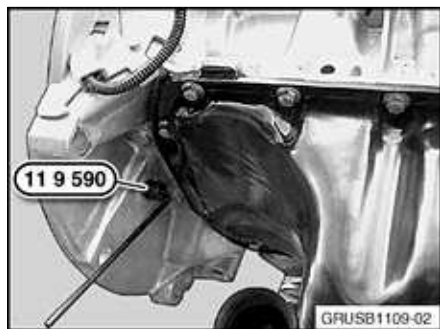
7. Disconnect the battery, remove ignition coils and spark plugs. Turn the engine by hand to move the flywheel to approximately 90° before TDC.

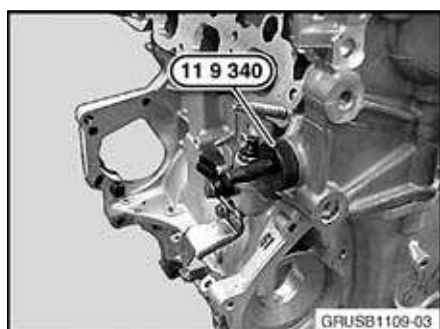
8. Install the locating pin (Special Tool 11 9 590) to lock the position of the engine.

9. Remove the chain tensioner and collect the residual oil with a shop towel.

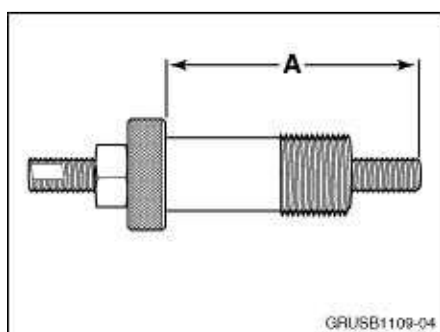
10. Fit the chain tensioner (Special Tool 11 9 340) without the seal ring and with the lock nut loose. Pretension the chain tensioner with Special Tool 00 9 250 to **0.6 Nm**. Finger-tighten the lock nut on Special Tool 11 9 340.

11. Remove the chain tensioner (Special Tool 11 9 340) from the engine, with the lock nut still tight. Measure the distance (A), as described in the illustration.

12. If distance (A) is less than 68mm (and the noise can be reproduced only between 1,600-1,800 rpm), then only replace the chain tensioner with P/N 11 31 7 607 551 (refer to parts list A), as per Repair Instruction REP 11 31 090 (Installing and removing/replacing chain tensioner piston N14).
13. If distance (A) is 68mm or greater (and the noise is reproducible both at 1,600-1,800 rpm range as well as at idle speed when cold), replace the following components in the list below (refer to parts list B). If you are uncertain regarding repair attempts already made, each chain tensioner part number is stamped on the outer sleeve. It must be removed from the engine in order to read the part number.
